路虎3.0/5.0汽油发动机主要存在的问题

Main issues with Land Rover 3.0/5.0 gasoline engines

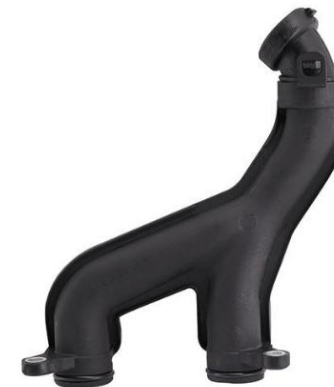
Y型管问题

问题：Y型管结构容易导致漏水的原因

Problem 1: The reason why Y-shaped pipe structure is prone to water leakage

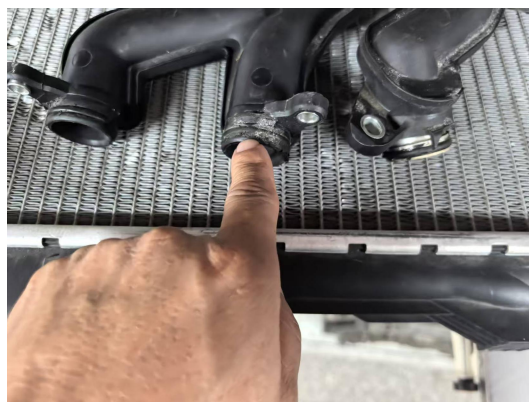
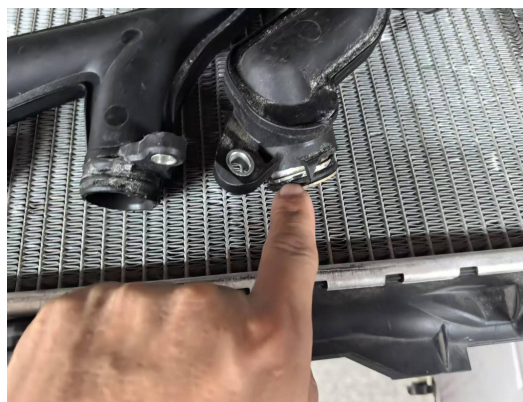
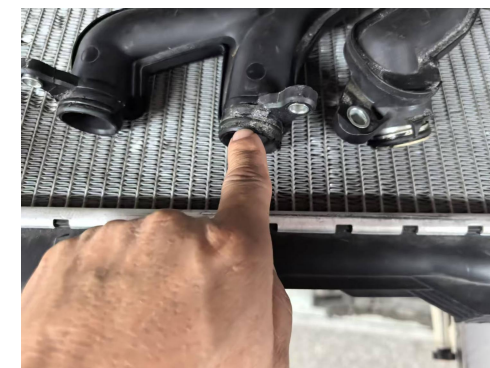
问题：Y型管胶圈设计结构过于简陋，容易导致微变形

The design structure of the Y-shaped pipe rubber ring is too simple, which can easily lead to slight deformation

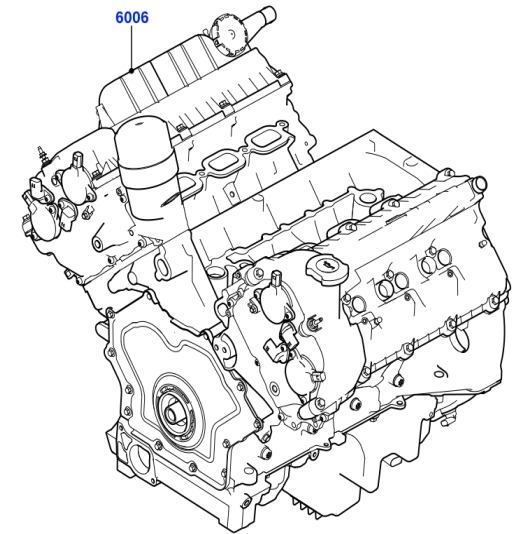
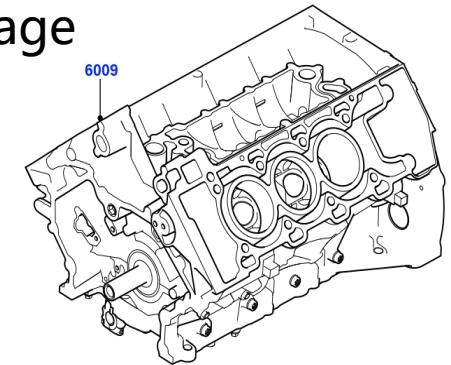
曲轴后油封问题

该款引擎维修过程中容易出现曲轴后油封安装不当导致漏油

During the maintenance process of this engine, improper installation of the crankshaft rear oil seal can easily lead to oil leakage

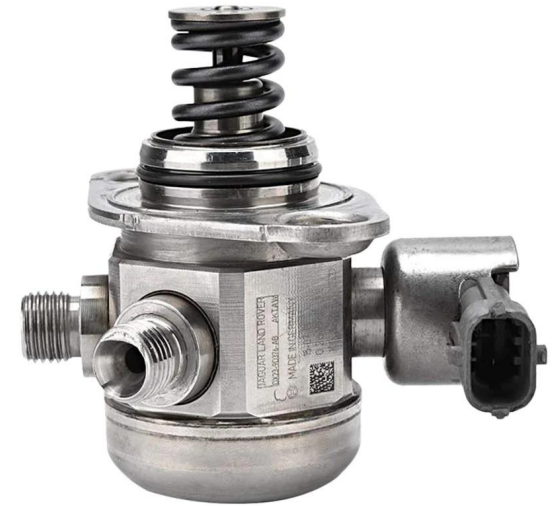
高压油泵问题

高压油泵易漏汽油使机油变稀，从而已导致轴瓦拉伤

The high-pressure oil pump is prone to leaking gasoline, causing the engine oil to become thinner, which has led to bearing strain
